CITY OF RICHLAND
Determination of Non-Significance

Description of Proposal: This project includes the construction of 9 various sized mini-storage buildings and an office building with associated parking and improvements. The total square footage of the proposed buildings is approximately 43,000 sf.

Location of Proposal: The project site is located at 1975 Hagen Road upon Assessor's Parcel No. 134082000001002. The site is at the southwest corner of Hagen Rd and Snyder Rd in Richland, WA 99352.

Critical Area Report Hagen Road Project

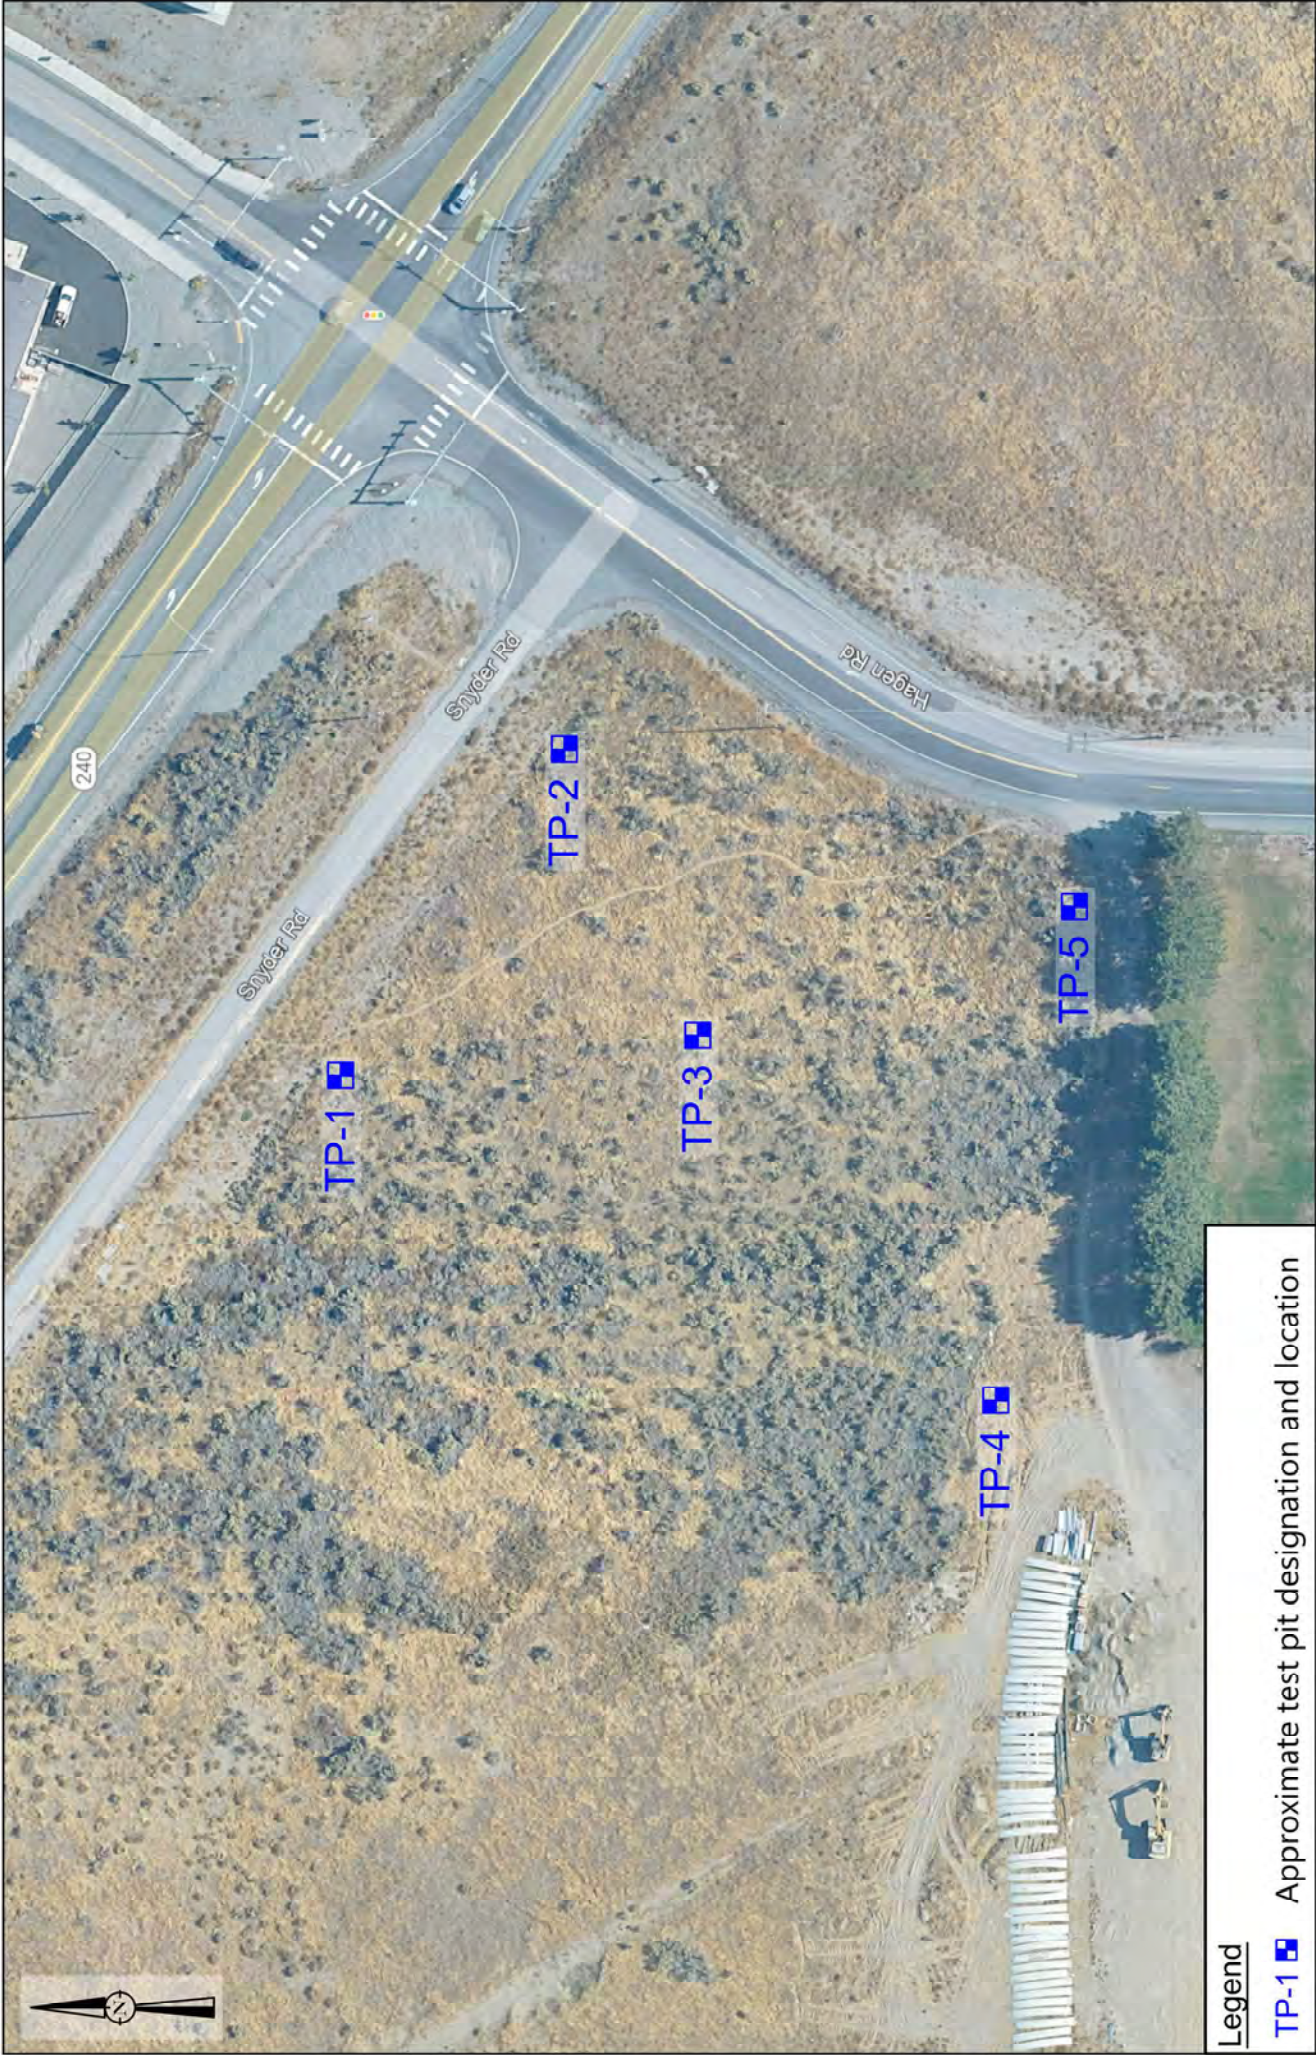
TP-1 Approximate test pit designation and location

The subsurface conditions are known only at the test pit locations on the date explored and should be considered approximate. Actual subsurface conditions may vary between excavation locations. The test pit locations are presented in **Figure 2** and the test pit logs are presented in **Appendix A**. Our geologist classified the in situ soil in the field and transported the soil samples to the laboratory for further examination and testing.

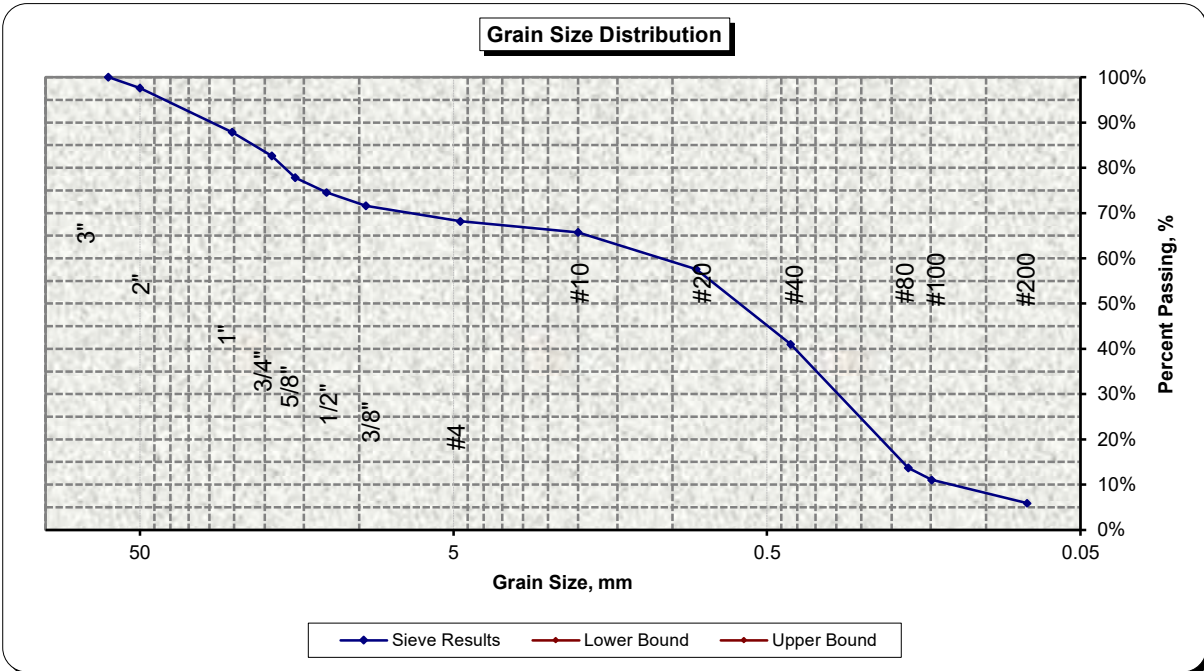
SIEVE ANALYSIS OF SOILS ASTM C 136/D 1140	SOIL MOISTURE DETERMINATION ASTM D 2216
---	---

Sieve Size:	Percent Passing:	Specs:	Sieve Size:	Percent Passing:	Specs:
4"			#4	68%	
3"			#8		
2 1/2"	100%		#10	66%	
2"	98%		#16		
1 1/2"			#20	58%	
1 1/4"			#30		
1"	88%		#40	41%	
3/4"	83%		#50		
5/8"	78%		#60		
1/2"	75%		#80	14%	
3/8"	72%		#100	11%	
1/4"			#200	5.9%

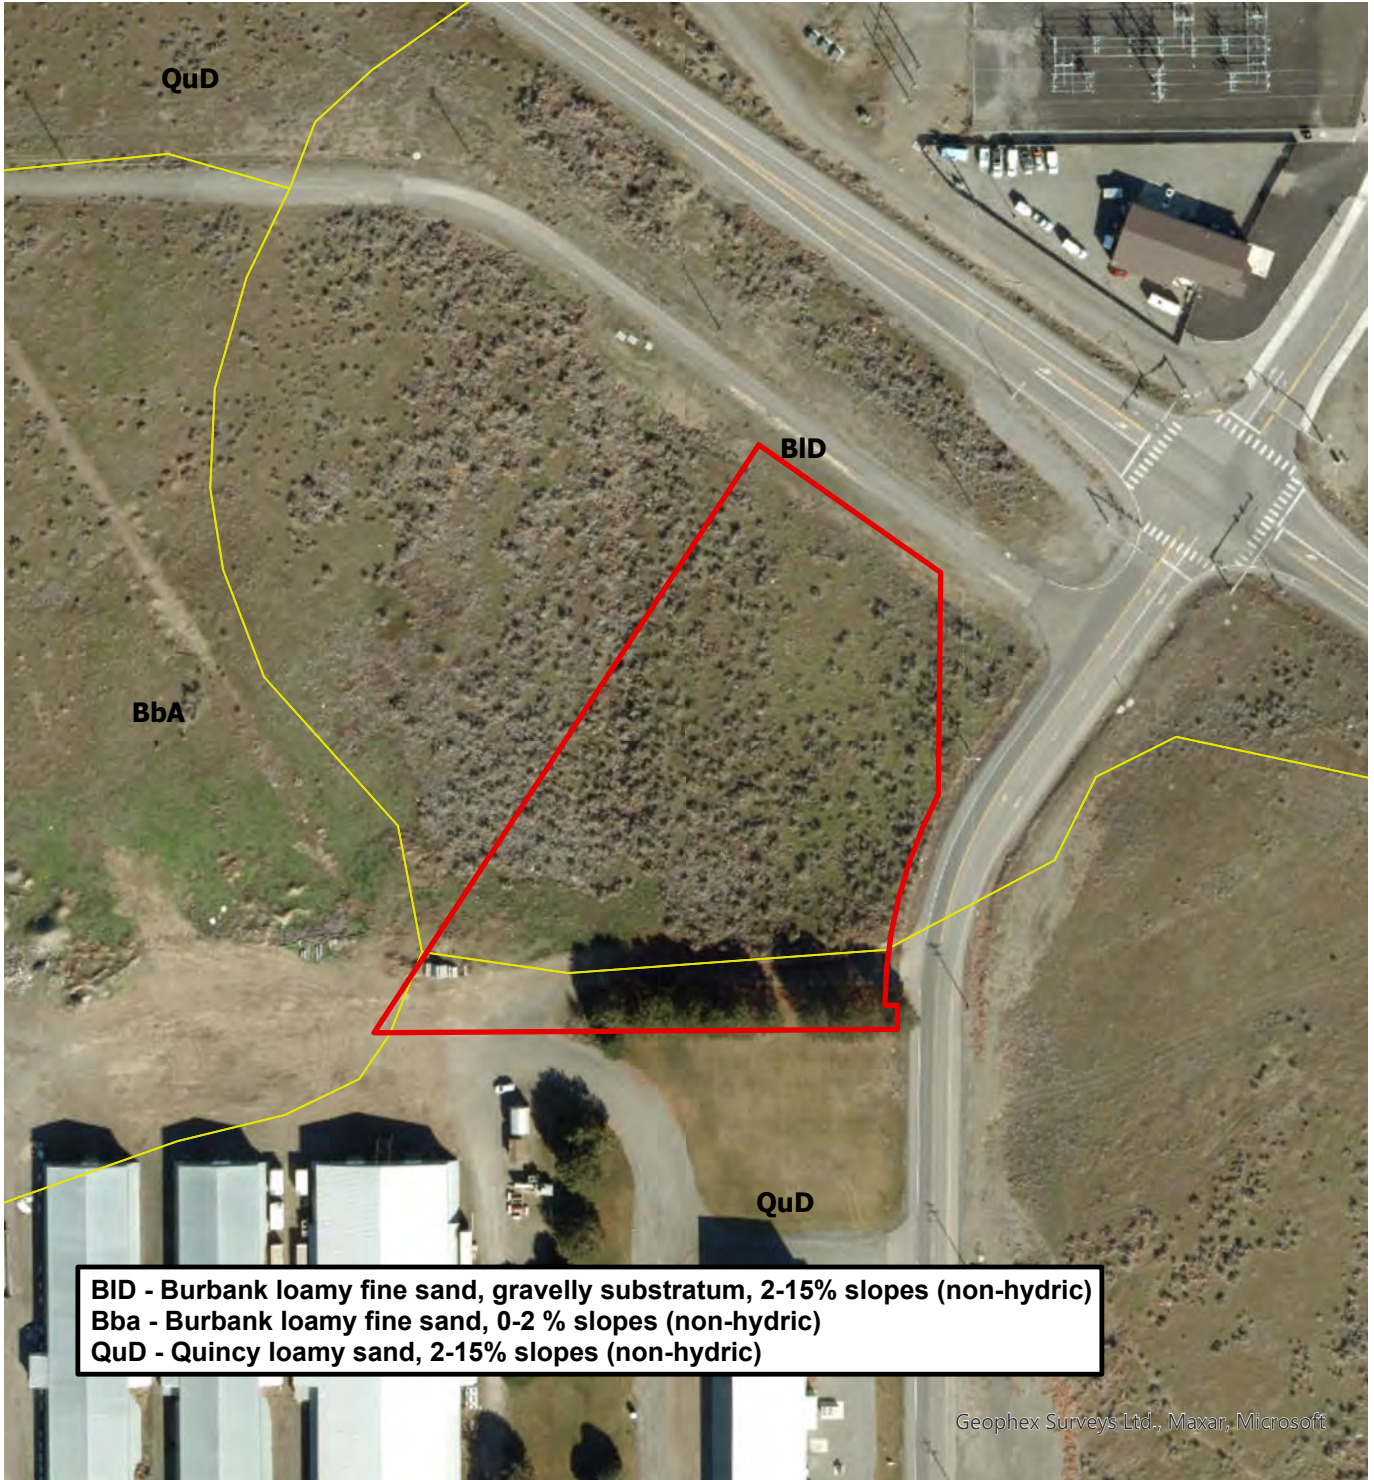
3

BID - Burbank loamy fine sand, gravelly substratum, 2-15% slopes (non-hydric)
Bba - Burbank loamy fine sand, 0-2 % slopes (non-hydric)
QuD - Quincy loamy sand, 2-15% slopes (non-hydric)

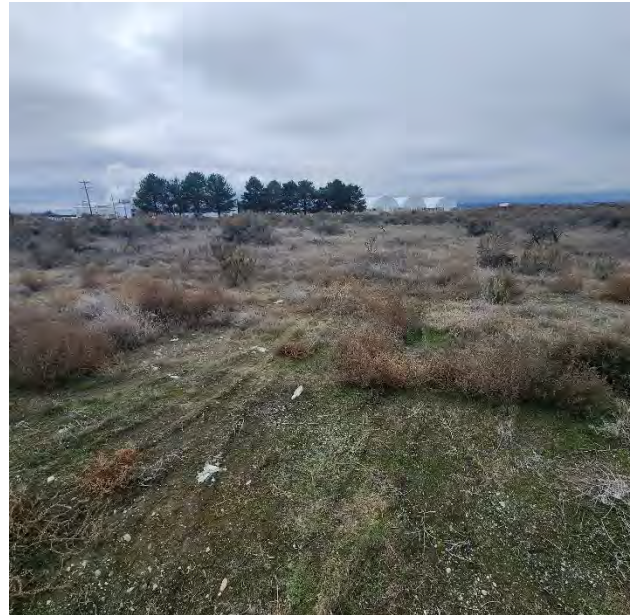
Photo 2. Tire track depressions seen at northern terminus of study area

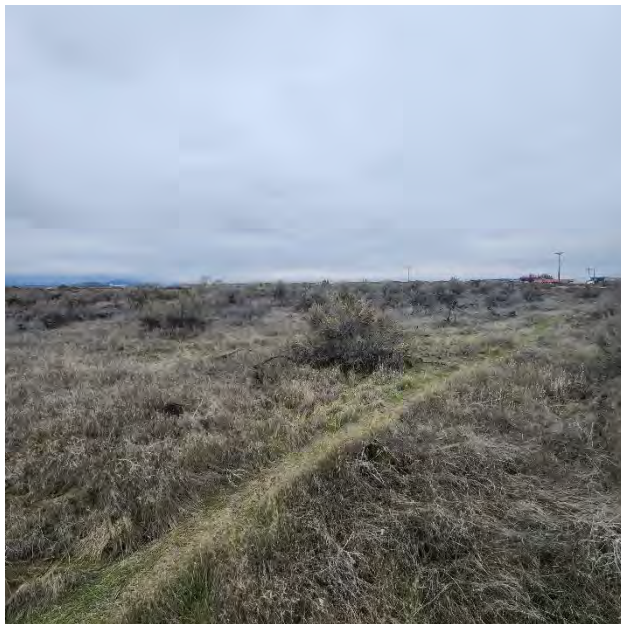
Photo 3. Game trail transecting study area (facing west)

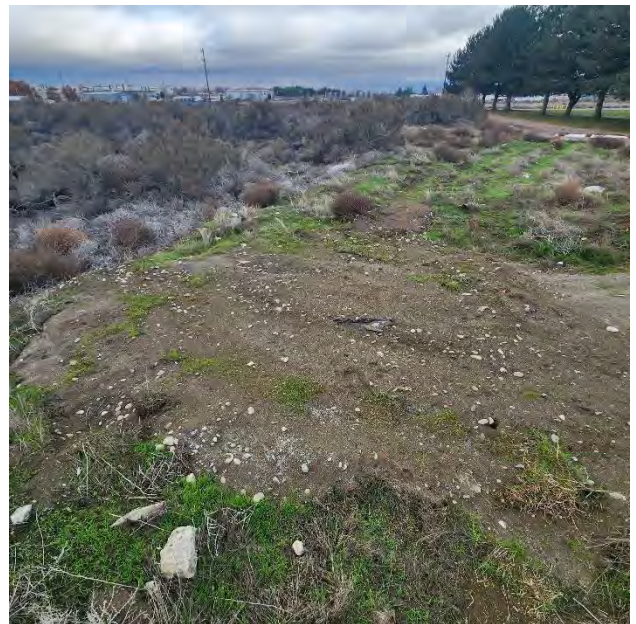
Photo 8. Soil fill area (facing east)

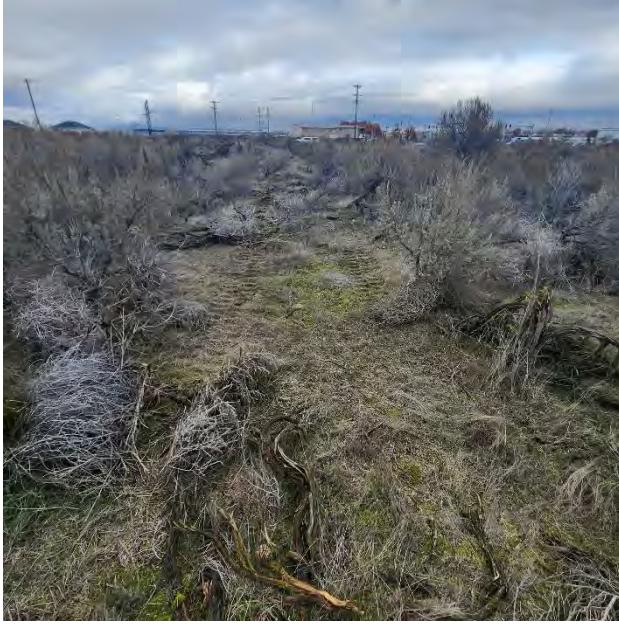
Photo 9. Tire track depressions seen in southwestern corner of study area (facing northeast)

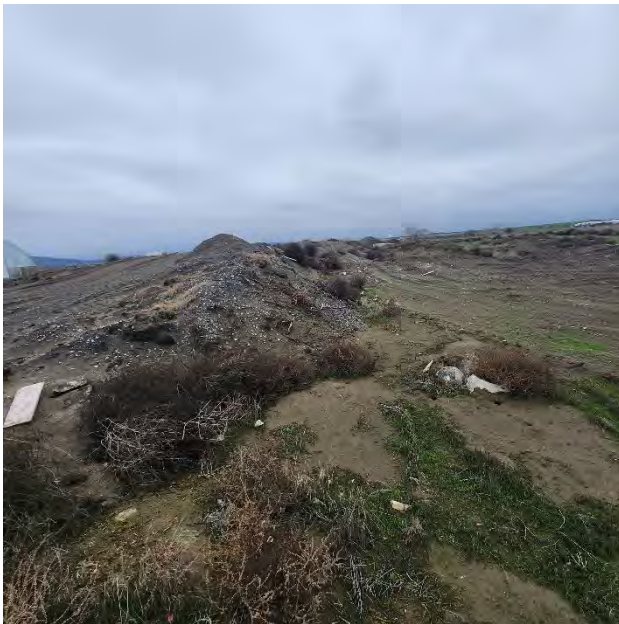
Photo 11. Soil stockpile (facing southwest)
