File No. EA2020-101

**CITY OF RICHLAND**  
**Determination of Non-Significance**

**Description of Proposal:** The Country Ridge Home Owners Association proposes to restore approximately 0.54 acres of Category 4 wetlands and its associated regulatory buffer.

# **WETLAND DELINEATION REPORT**

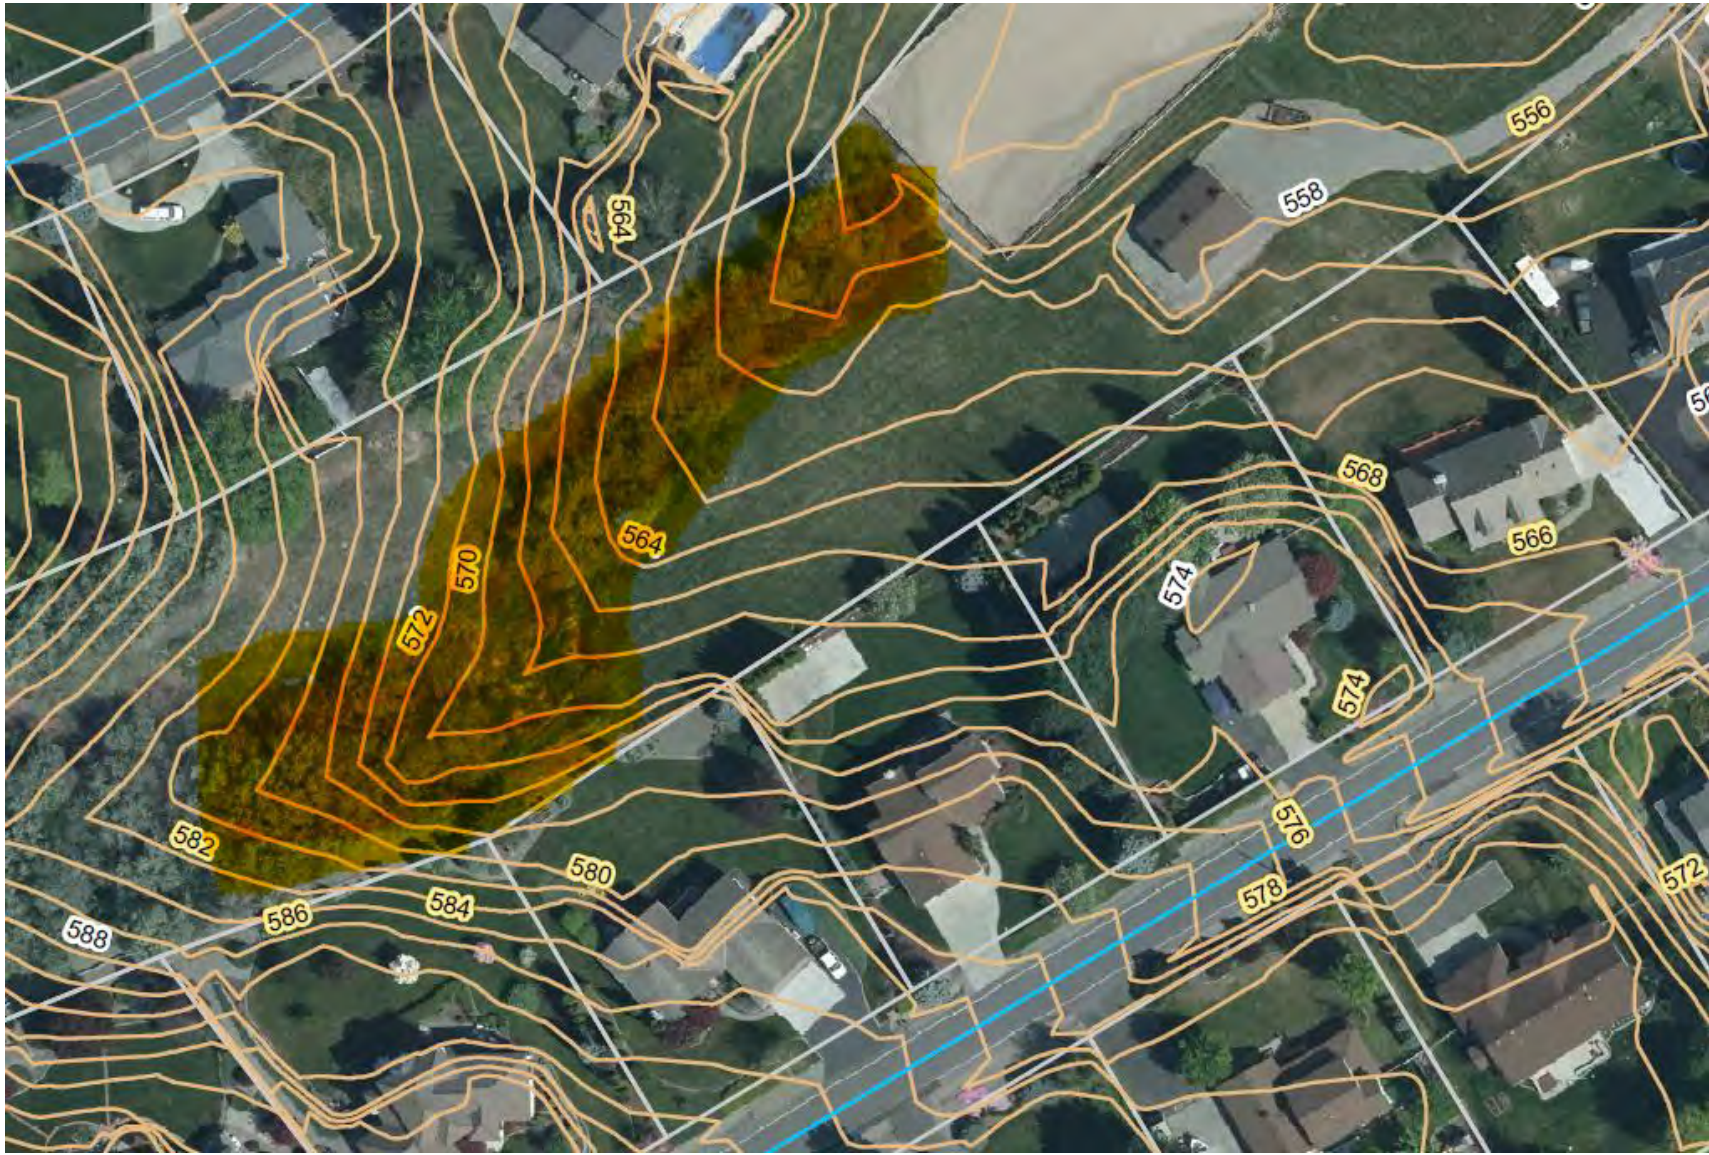
**CRHOA Wetland Restoration Plan – Area of Applicability (shaded) with topography annotations  
SEPA Checklist supplement**

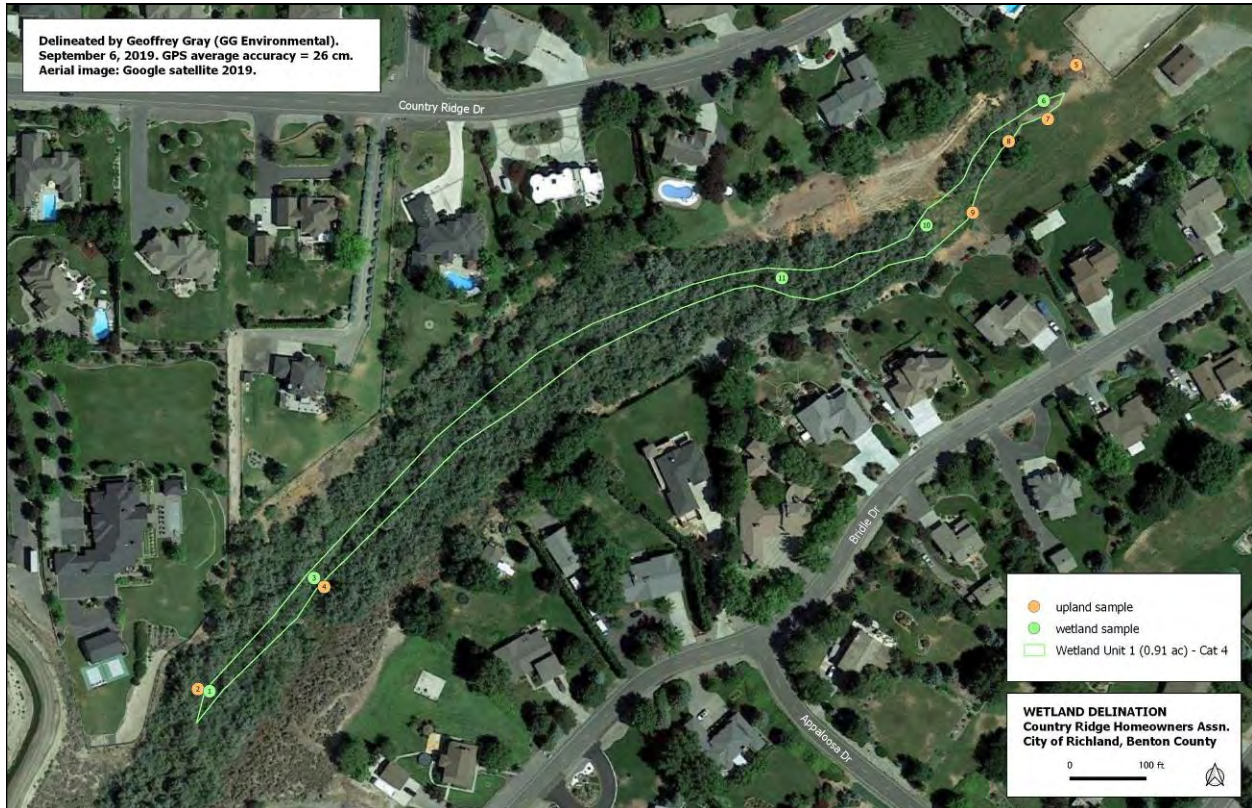
**Figure 2. Wetland Delineation Map<sup>4</sup>**

Fieldwork took place in the late summer. It had not rained immediately prior to site visit, but skies were overcast. Eleven sample locations were investigated to determine the presence or absence of wetland indicators (**Figure 2**).

It was determined that wetland boundaries are justified where (1) groundwater or saturation was observed within 12 inches of the soil surface, (2) hydric soil indicators were observed, and (3) the plant community was dominated by plant species with wetland indicator statuses of FAC, FACW, or OBL.

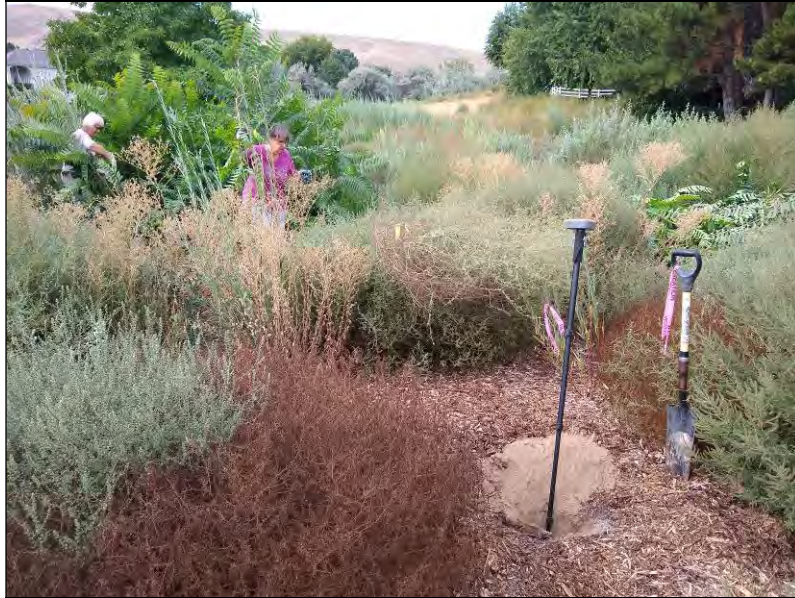
Photo 1. Soil Pit #5 past the wetland's delineated eastern terminus.  
View toward the southwest.

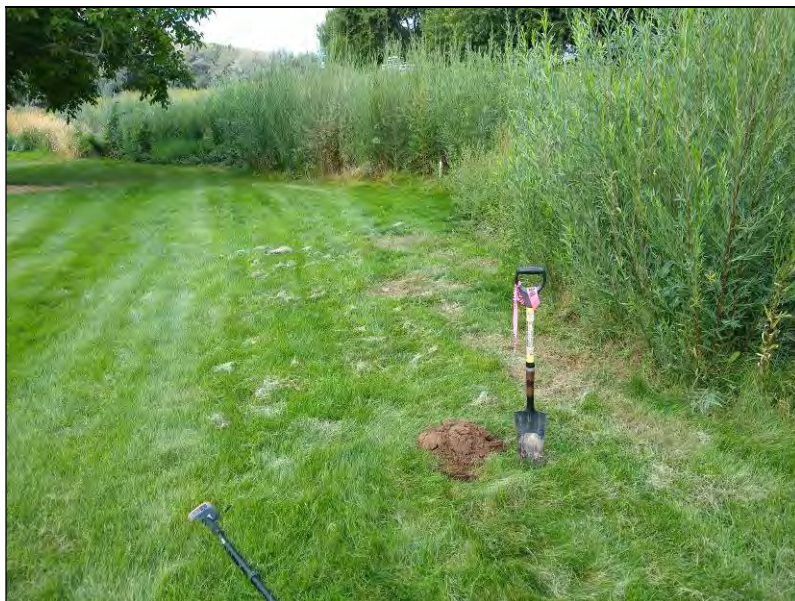
Photo 2. Soil Pit #7. View toward the southwest.

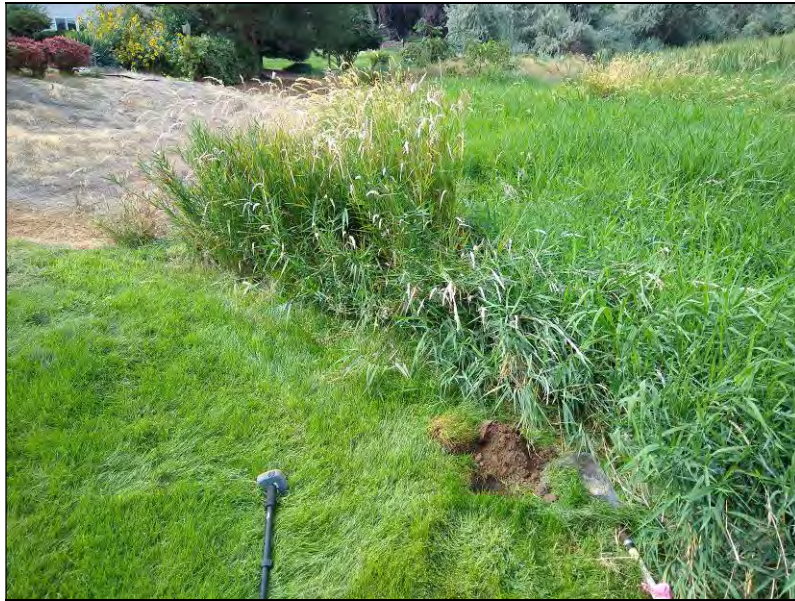
Photo 3. Soil Pit #9. View toward the southwest.

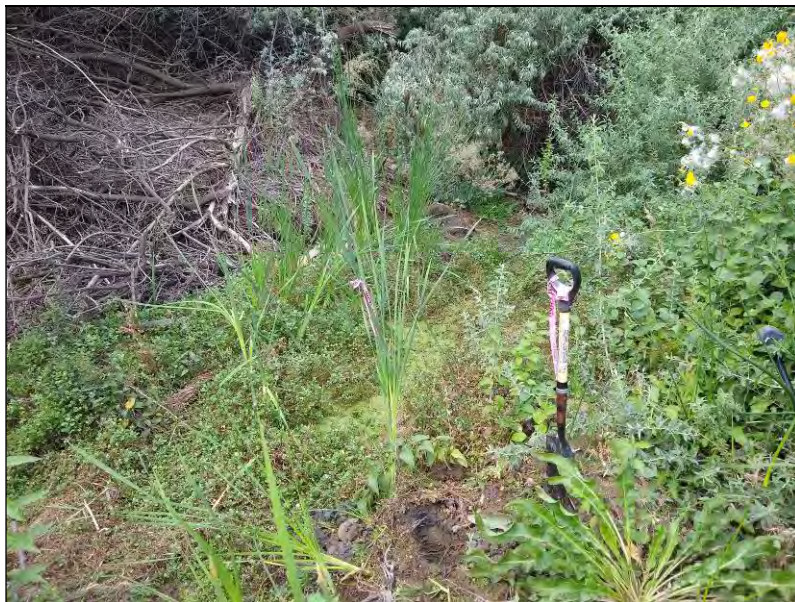
Photo 4. Soil Pit #11 where water emits from the ravine floor.  
View toward the west.

Groundwater was observed at the soil surface in two locations on the ravine bottom. The larger of the two wet areas was present in the lower half of the ravine, where topography is less steep. According to residents, the extent of surface moisture varies but has never been observed to extend to the horse arena past the wetland's delineated eastern terminus. Since water in the wetland infiltrates short of the arena, without connecting to another aquatic resource, the wetland conforms to the definition of isolated.

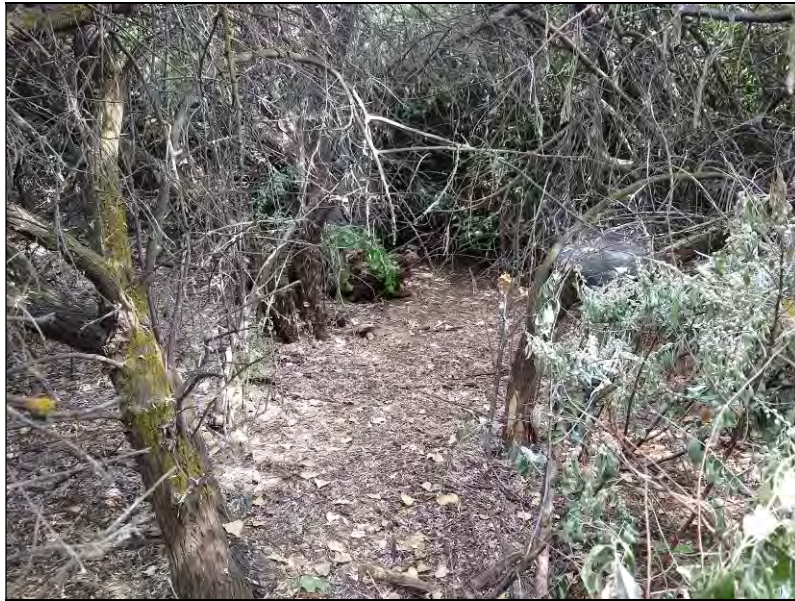
Photo 5. Example of the Russian olive understory.

The vegetation community in the survey area is dominated by a climax community of mature Russian olive trees that occupy not only the ravine bottom, but also the more xeric side slopes. They are able to do so because adjacent watering of residential landscapes has provided hyporheic moisture on the slopes sufficient for them to spread. The dense canopy largely inhibits growth of herbaceous plants in the understory due to shading.

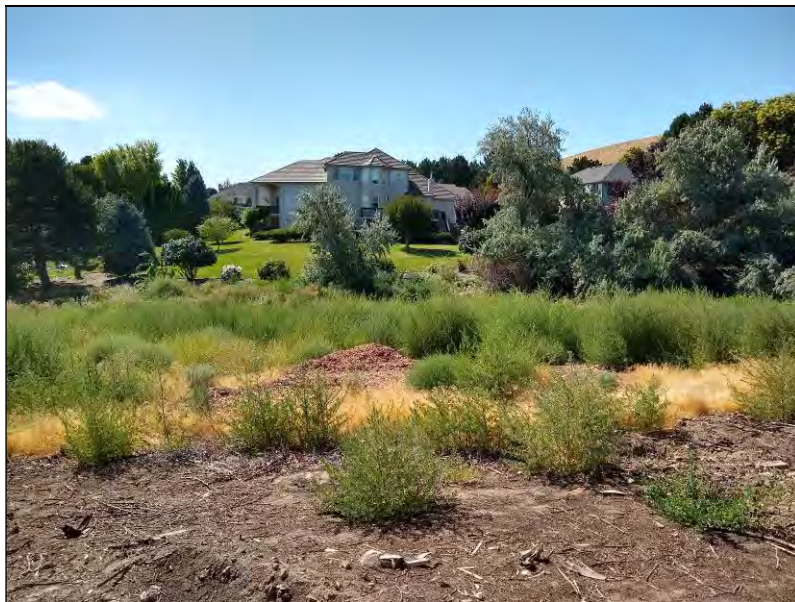
Photo 6. Example of weed colonization along the wetland where Russian olives were removed. View toward the south, across from Soil Pit #11.

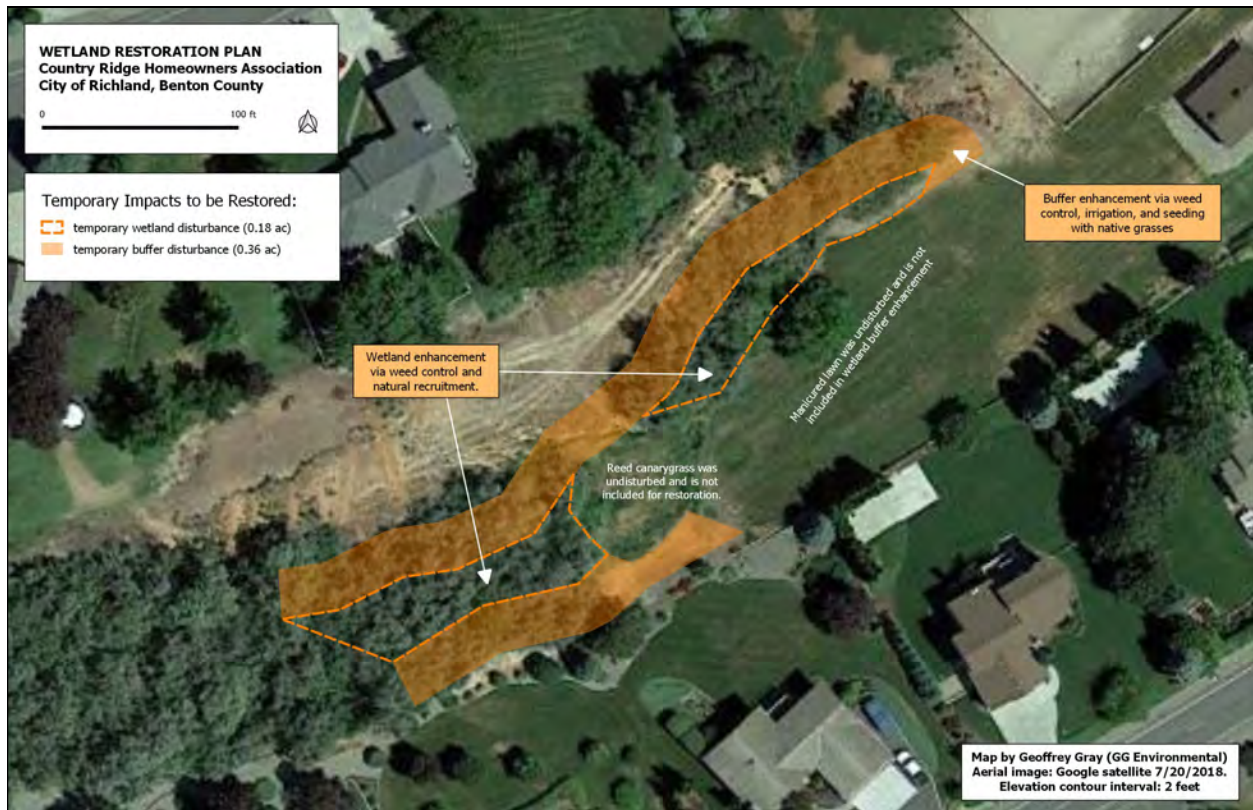
**Figure 2. Wetland Impacts and Restoration Plan**

The areas to be restored are illustrated in **Figure 2**.

In order to prepare the buffer for weed control, existing weeds will be mowed and the soil surface mechanically scarified via tractor-mounted discs and/or rototiller. Disturbance of the soil is expected to increase the germination rate of weed seeds within the soil profile when irrigation is applied.

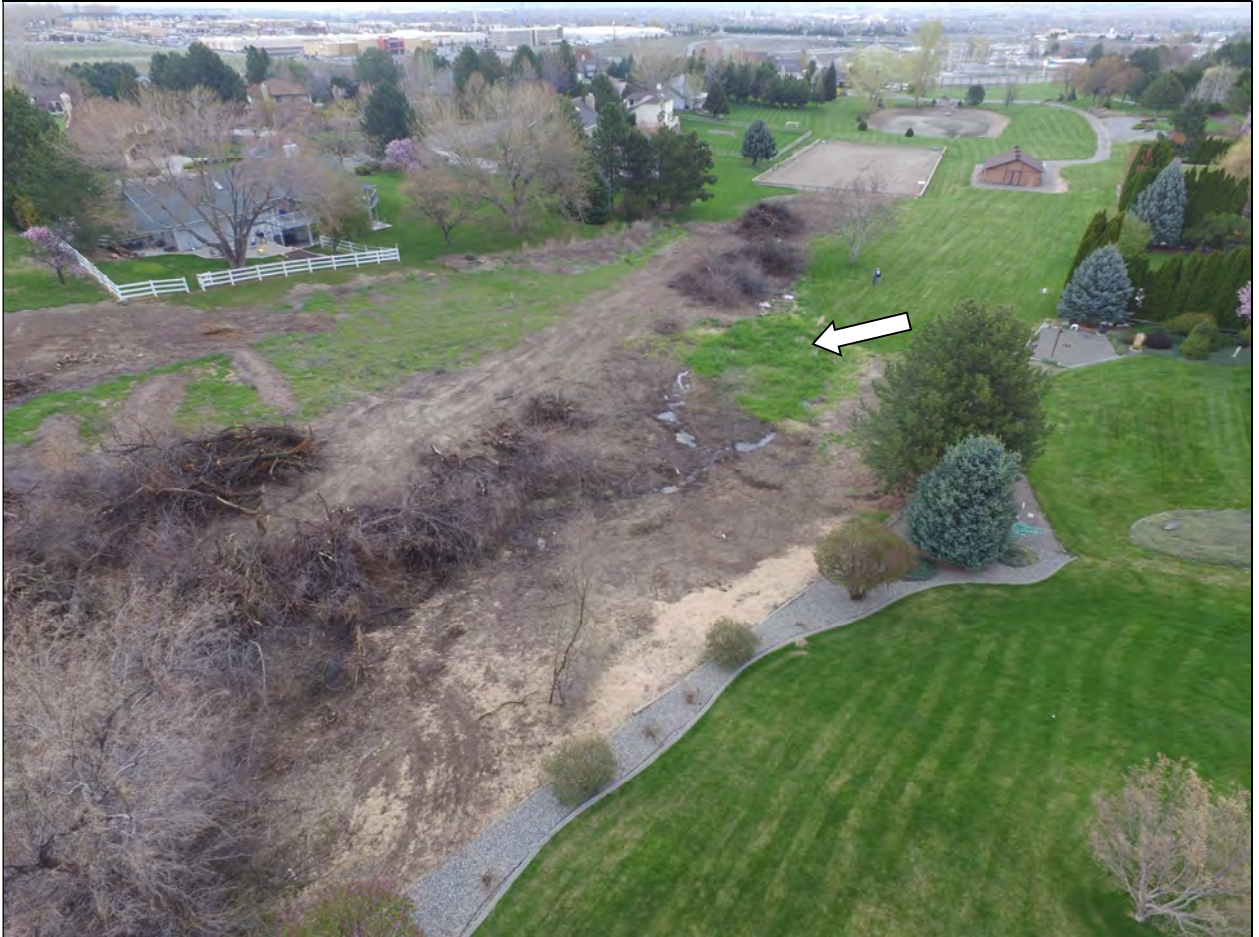
Photo 1. Russian olive tree removal in March 2019. Note reed canarygrass patch (white arrow) in the wetland that was undisturbed. View toward the northeast.

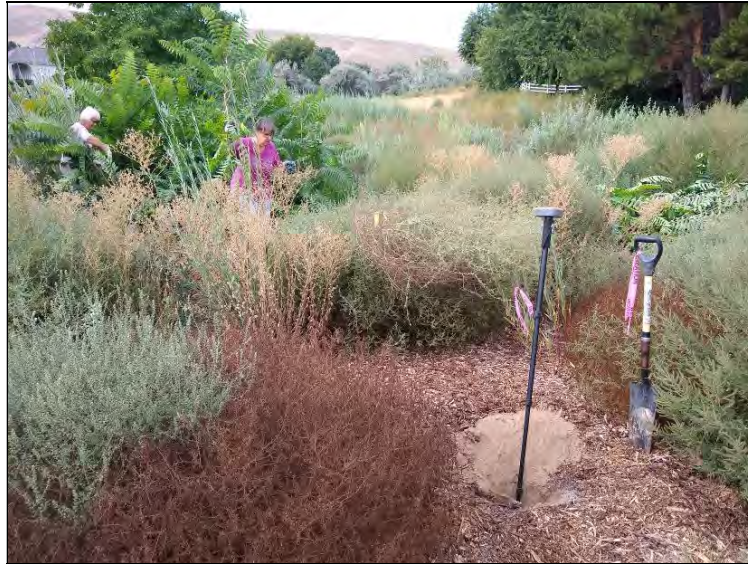
Photo 2. Wetland buffer dominated by weeds in September 2019.  
View toward the northwest.

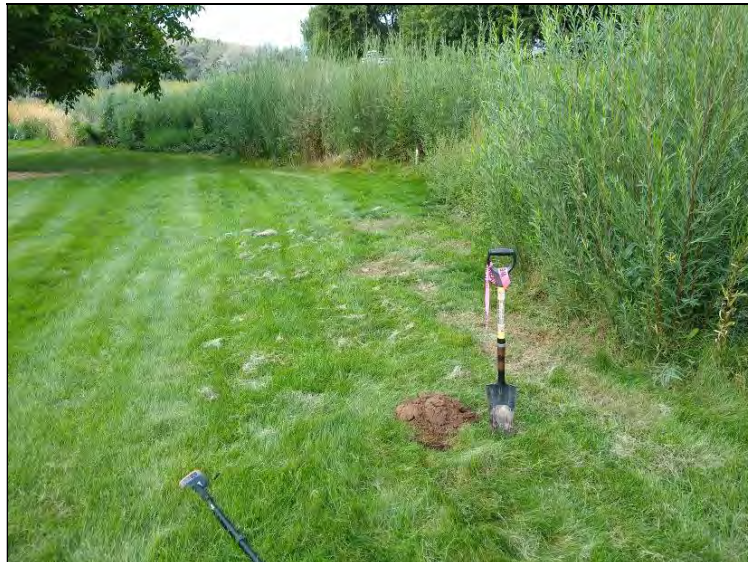
Photo 3. Rapid recovery of existing native wetland vegetation (coyote willow) in  
September 2019, adjacent to the manicured lawn. View toward the west.
